Test report – Masonry based on lime mortar

Determining the Secant Modulus of Elasticity of Masonry based on lime mortar and measuring the long-term compressive and flexural strength of hardened lime mortar

2015-10-30, Danish Technological Institute, Masonry, Aarhus

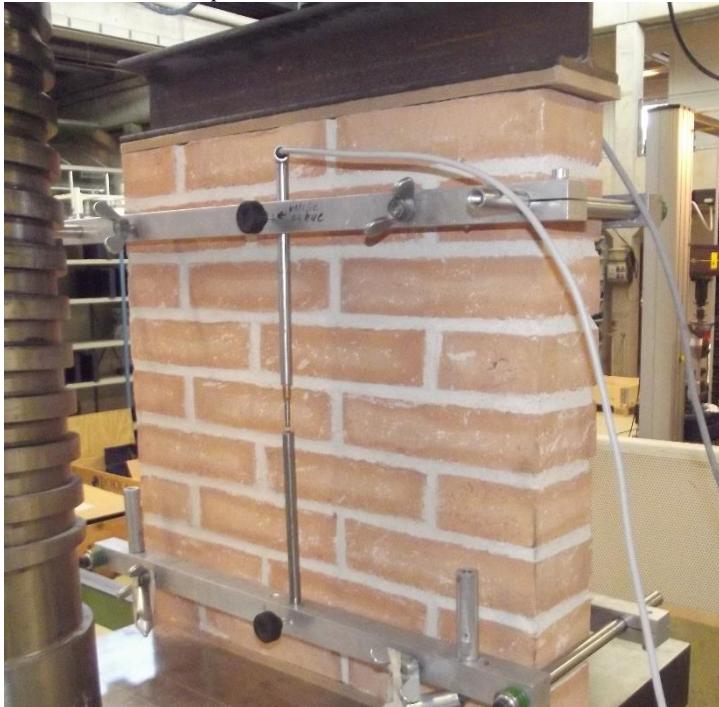
The deformation of the wall during the compression was measured with two *HBM 50 mm transducers*. The transducers were pushed downwards onto a steel rod, which was fixated to a lightweight aluminum frame. The mean deformation in the center of the wall was determined based on the mean value of the two measured deformations on each sides of the wall. The stiffness of the frame is assumed to be infinite in the vertical direction.

In order to determine the strains, the initial distance between the two aluminum frames was measured. The test was recorded with the data aquisition hardware *HBM Spider8* and the software *CatmanEasy*.

Picture 1: Test setup.

Above and below the wall a soft 10 mm layer of masonite was placed to reduce the irregularities on the surfaces. A steel profile was mounted above the masonite layer to distribute the load equally. The weight of the distribution profile was included in the calculations. The walls were tested in an Amsler 500 ton compression machine.

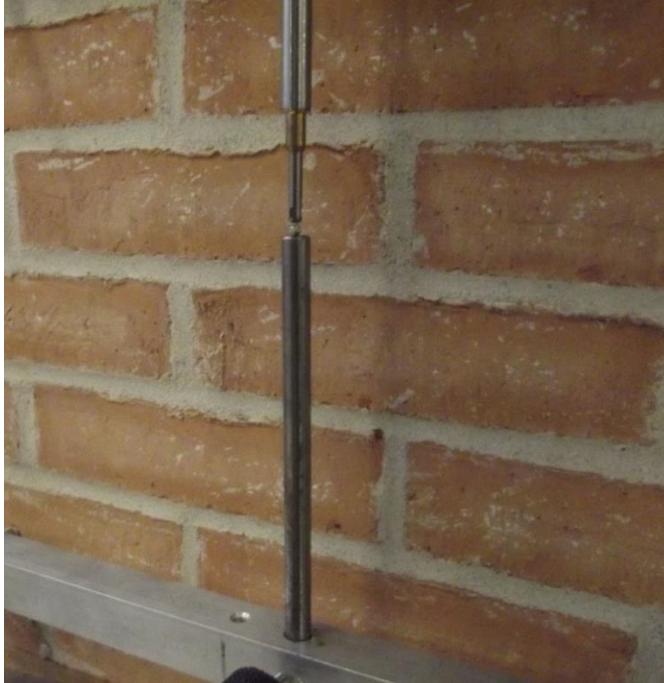
Picture 2: Placement of the deformation transducer on the steel rod.

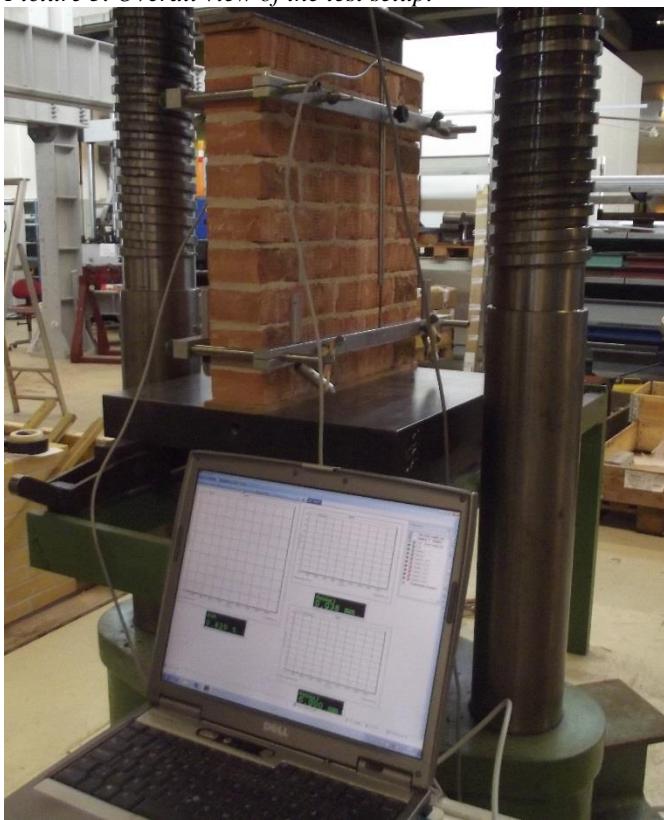
Picture 3. Overall view of the test setup.

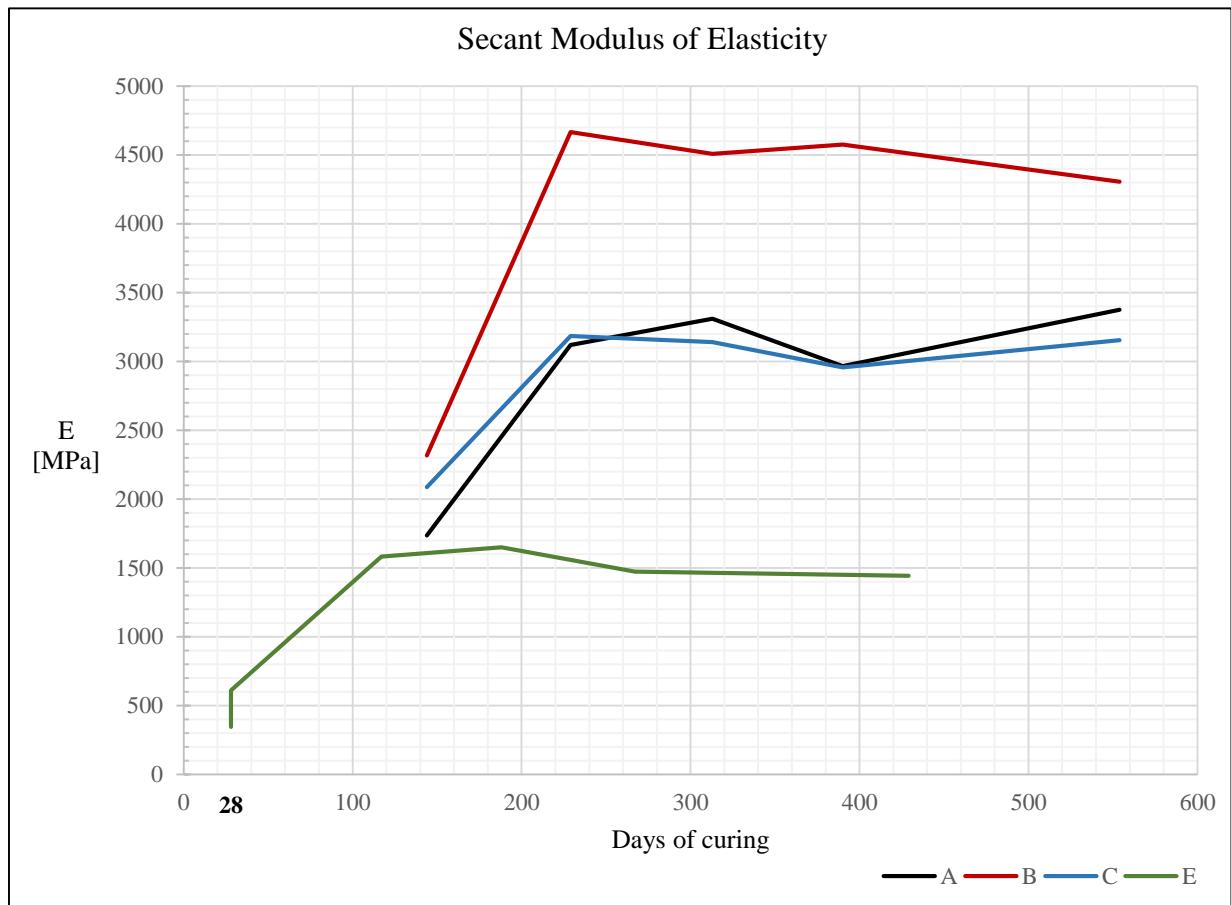
Graph 1. The secant modulus of elasticity over time, for wall type A, B, C & E.

The results for the secant modulus of elasticity appear on table 1 and 2, while the strength values appear on table 3. The results for the hardened lime mortar prisms appear on table 4.

Built Date	Curing days Wall	28 05-02-14	60 04-11-13	117 05-05-14	144 27-01-14	188 15-07-14	229 22-04-14	267 02-10-14	313 15-07-14	390 30-09-14	429 13-03-15	554 13-03-15
05-09-13	A		3365 ^a		1736		3120		3310	2965 ^c		3374 ^{bc}
05-09-13	B		5533 ^a		2317		4665		4507 ^c	4574 ^c		4306 ^{bc}
05-09-13	C		3968 ^a		2086		3184		3139 ^c	2957 ^c		3154 ^{bc}
08-01-14	E1			1581		1649 ^c		1472 ^c			1443 ^{bc}	
08-01-14	E2	345 ^b										
08-01-14	E3	610 ^b

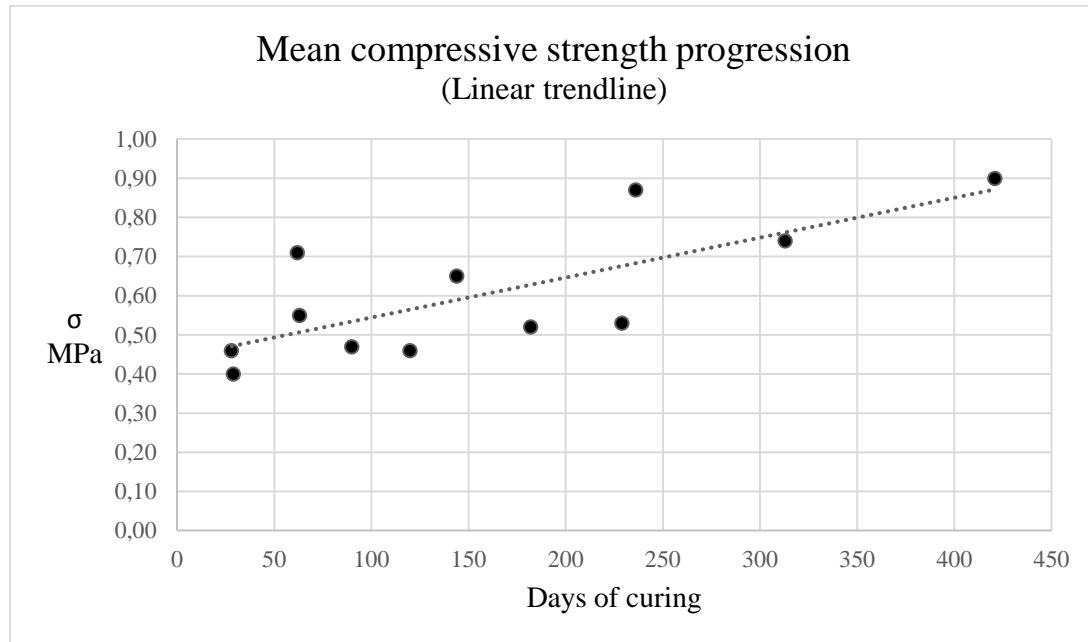
Graph 2: Mean compressive strengths of hardened lime mortar 7.7% during a period from 28 days to 421 days of curing.

The strength progressions are illustrated on graph 2 and 3 for the mean compressive- and flexural strength.

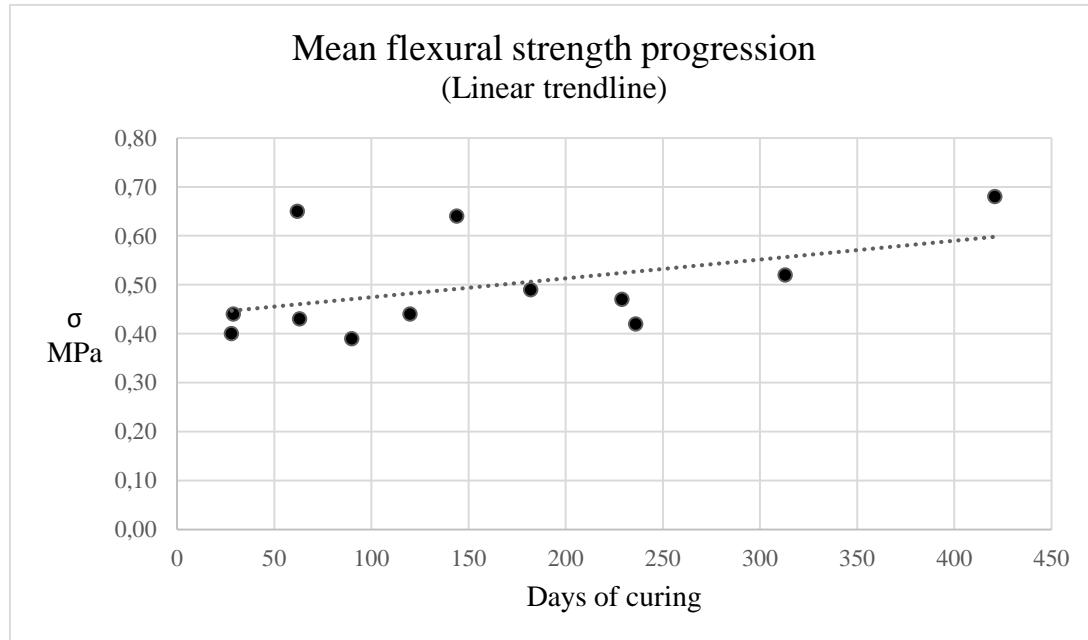
Graph 3: Mean flexural strengths of hardened lime mortar 7.7% during a period from 28 days to 421 days of curing

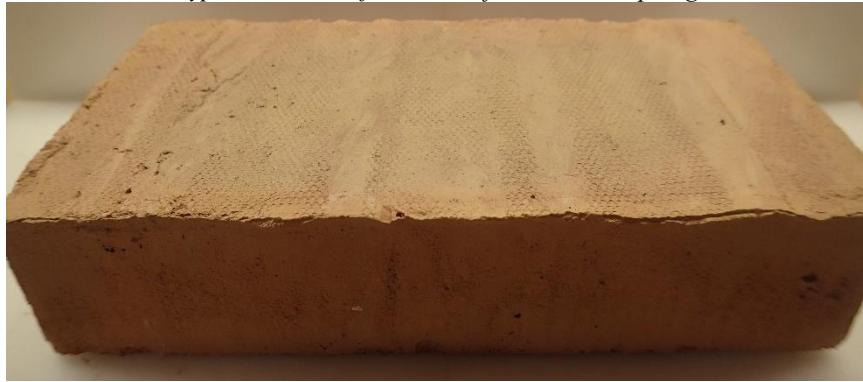
Picture 1. Brick type A: "Rosé, soft-molded" from Vedstårup Teglværk A/S

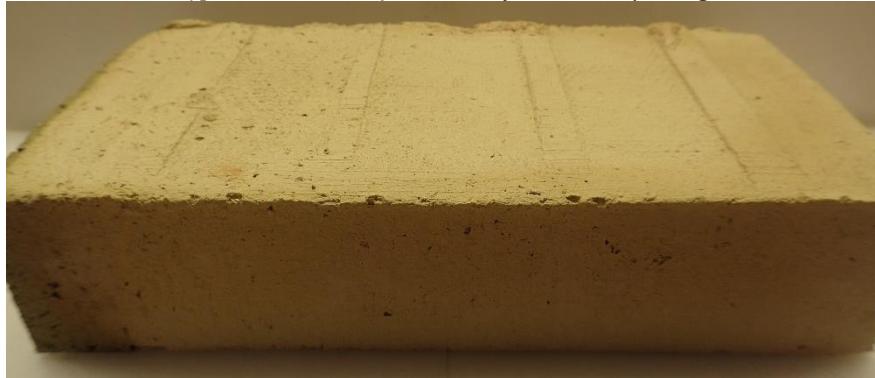
Picture 2. Brick type B: "Yellow, soft-molded" from Prøvelyst Teglværk A/S

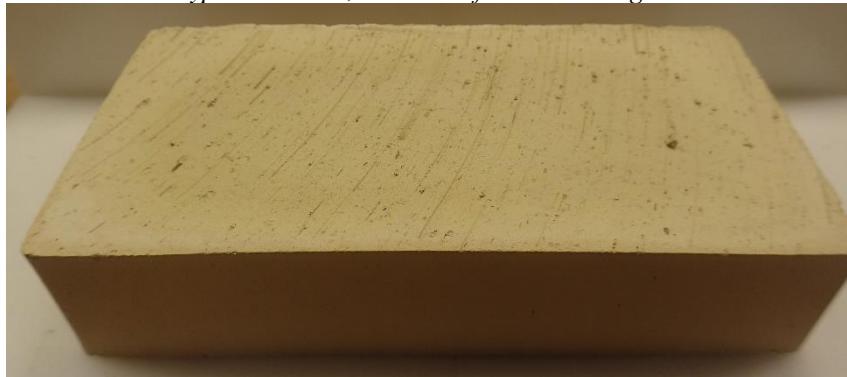
Picture 3. Brick type C: "Yellow, extruded" from Vindø Teglværk A/S

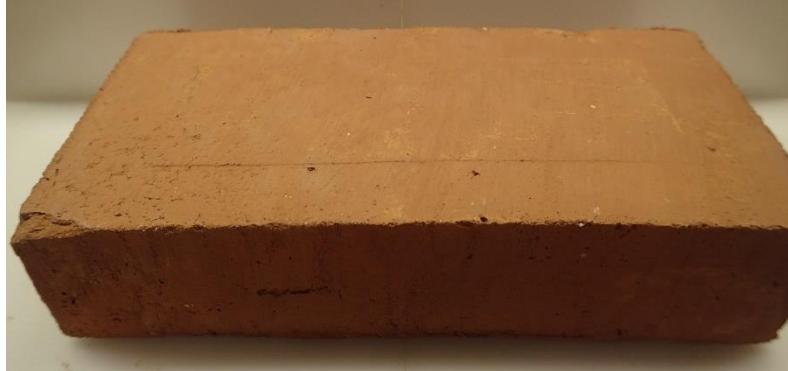
Picture 4. Brick type E: "Red, soft-molded – 2.2.07" from "Helligsø Teglværk A/S"

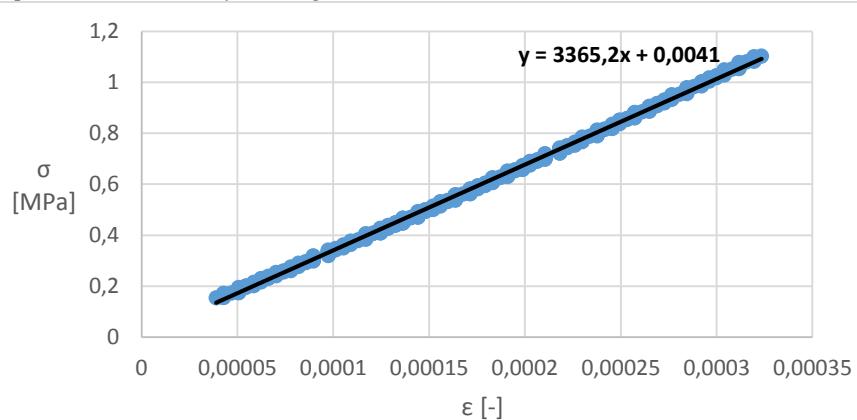
Graph 1: Wall A, 60 days curing.

Stress-strain diagrams for each test are given in Annex 2.

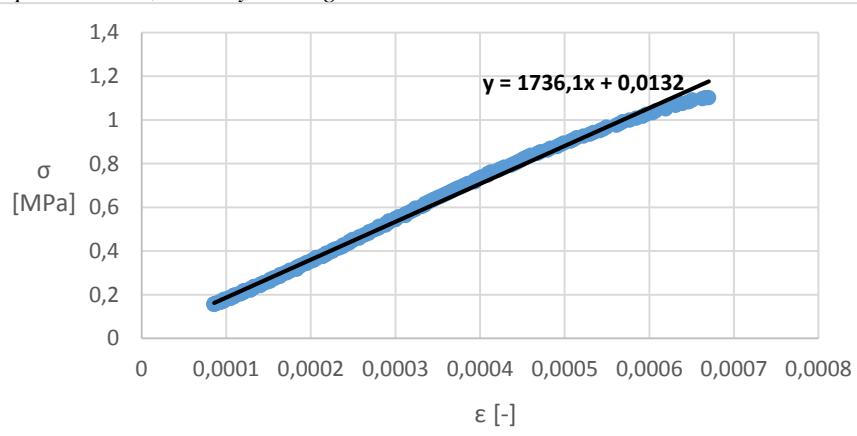
Graph 2: Wall A, 144 days curing.

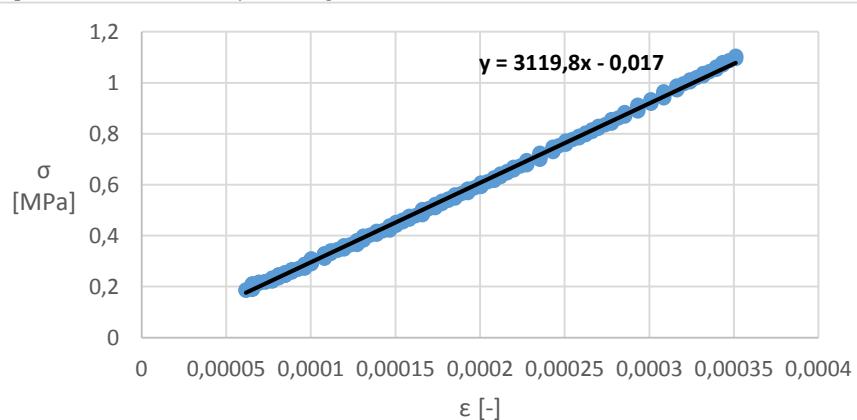
Graph 3: Wall A, 229 days curing.

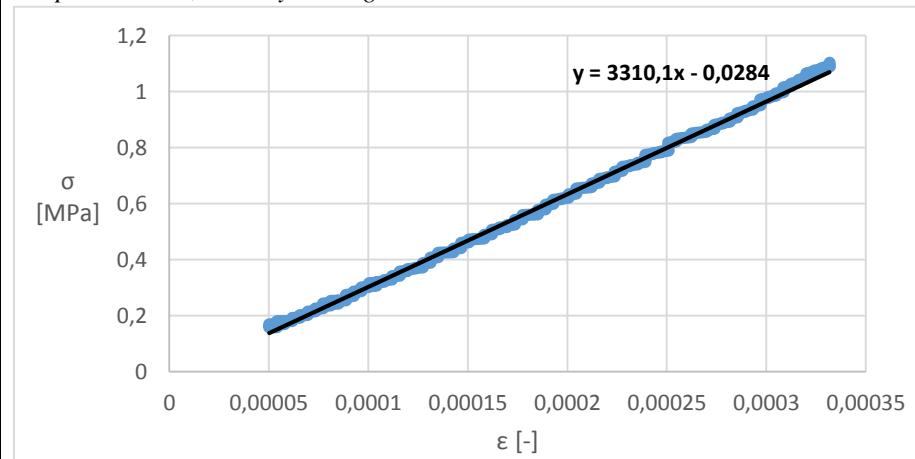
Graph 4: Wall A, 313 days curing

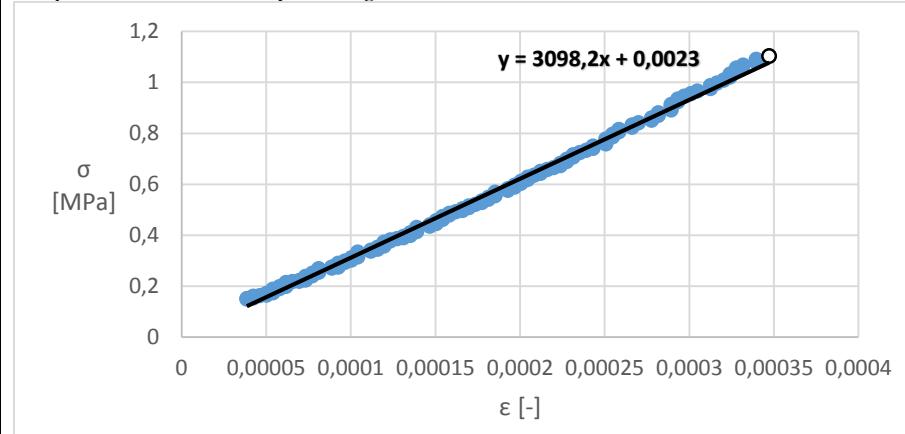
Graph 5: Wall A, 390 days curing – test 1

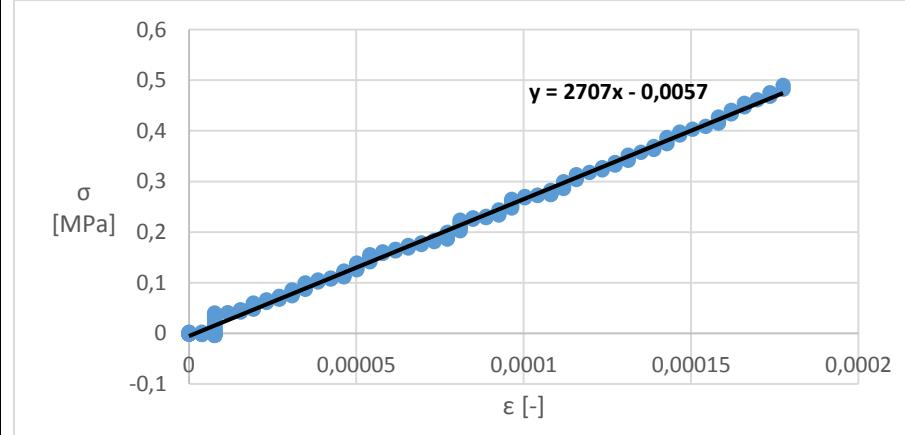
Graph 6: Wall A, 390 days curing – test 2

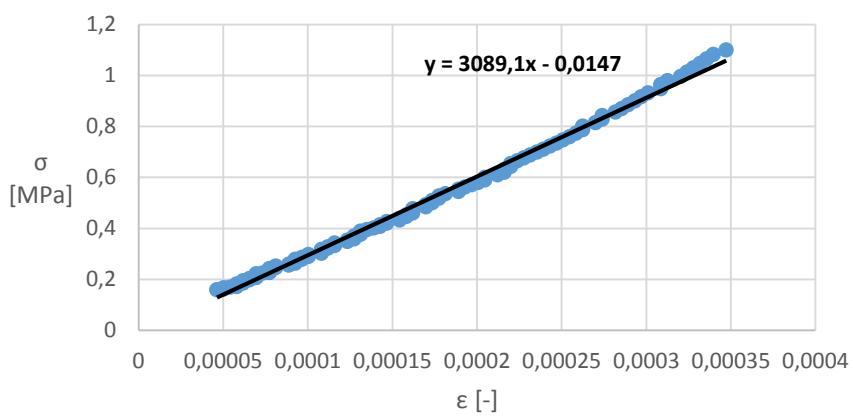
Graph 7: Wall A, 390 days curing – test 3

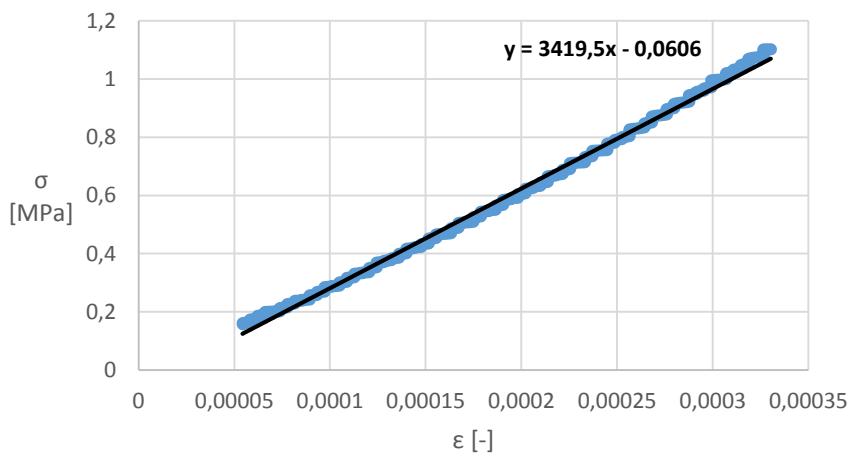
Graph 8: Wall A, 554 days curing – test 1

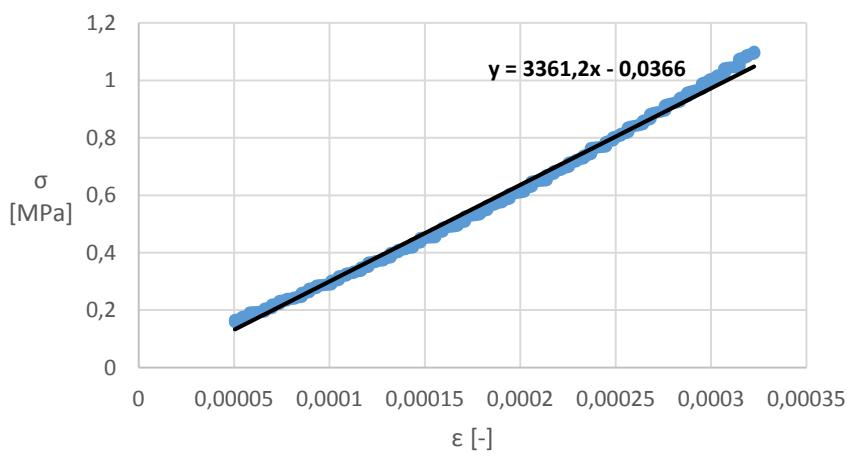
Graph 9: Wall A, 554 days curing – test 2

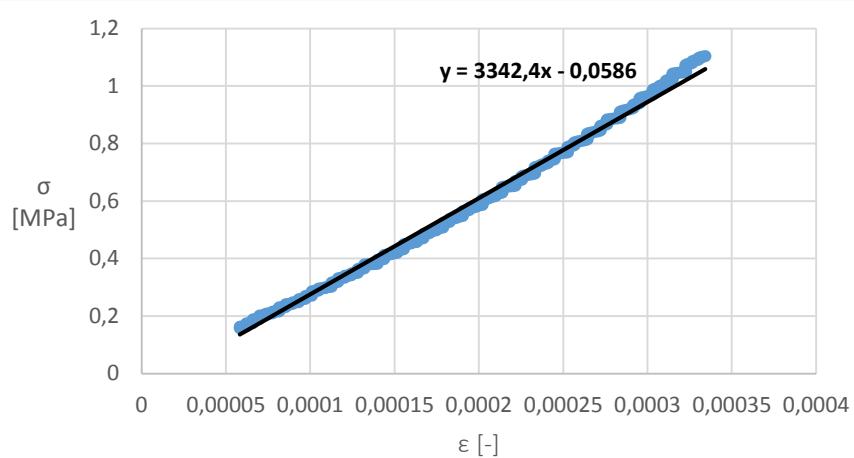
Graph 10: Wall A, 554 days curing – test 3

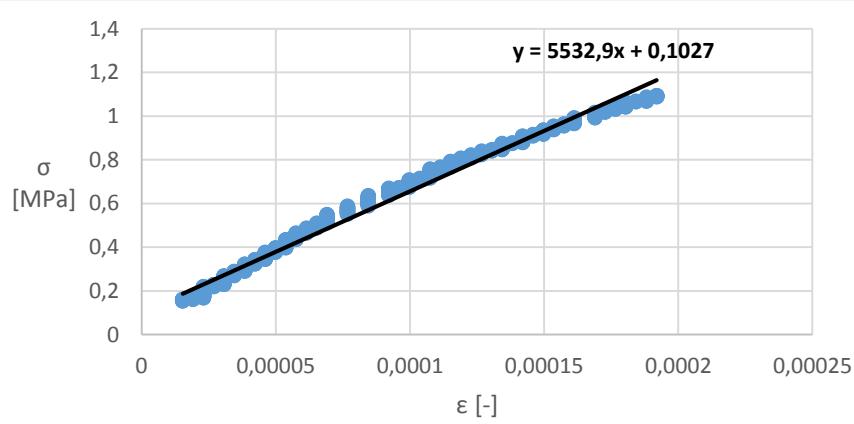
Graph 11: Wall B, 61 days curing.

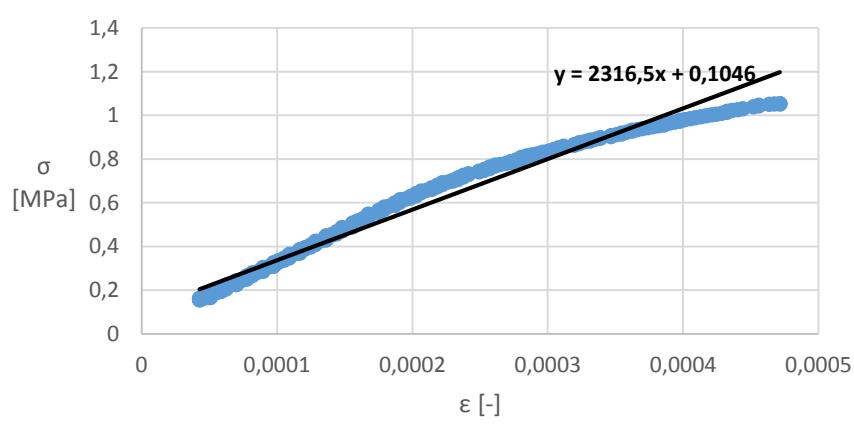
Graph 12: Wall B, 144 days curing.

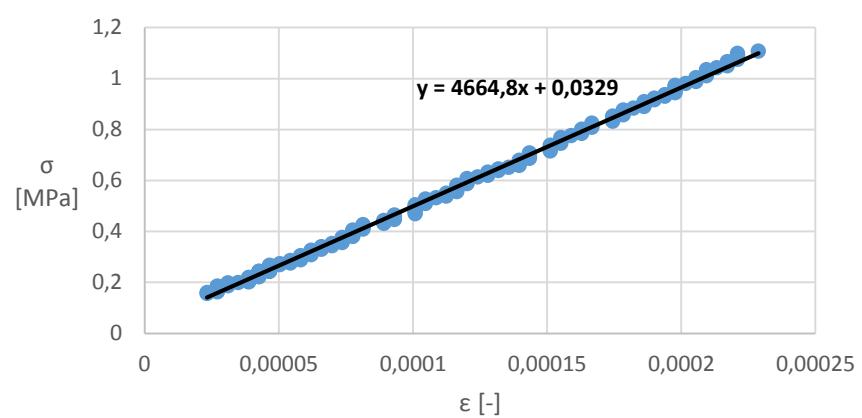
Graph 13: Wall B, 229 days curing.

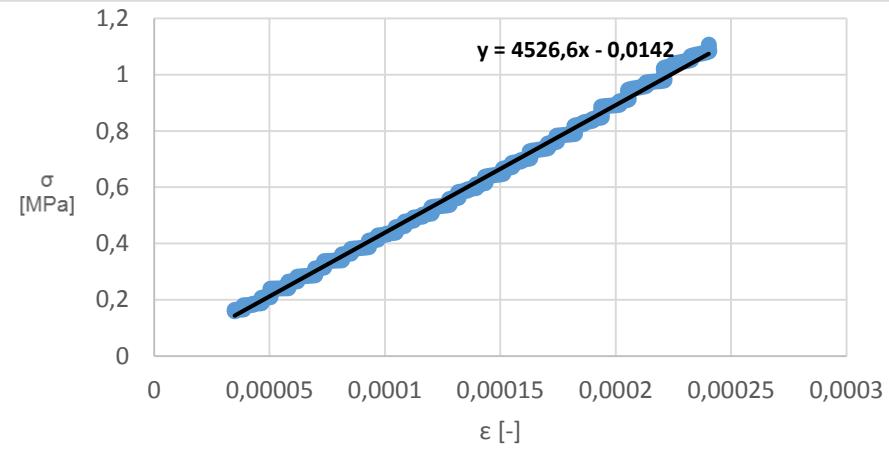
Graph 14: Wall B, 313 days curing – test 1.

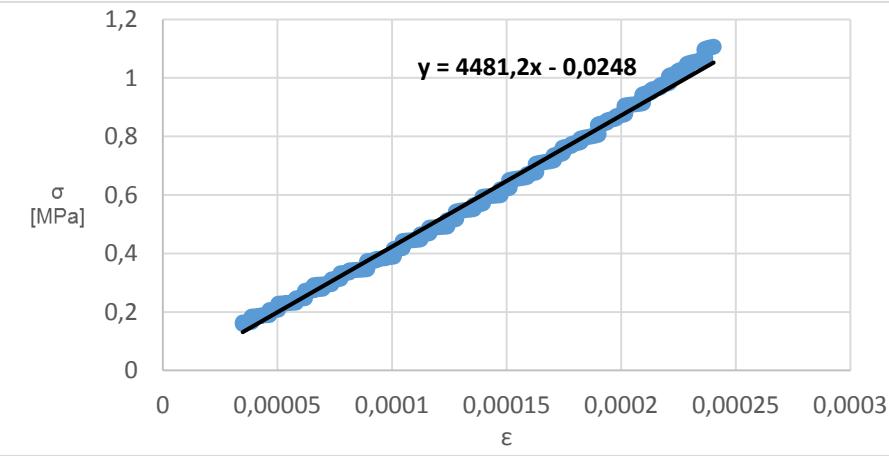
Graph 15: Wall B, 313 days curing – test 2.

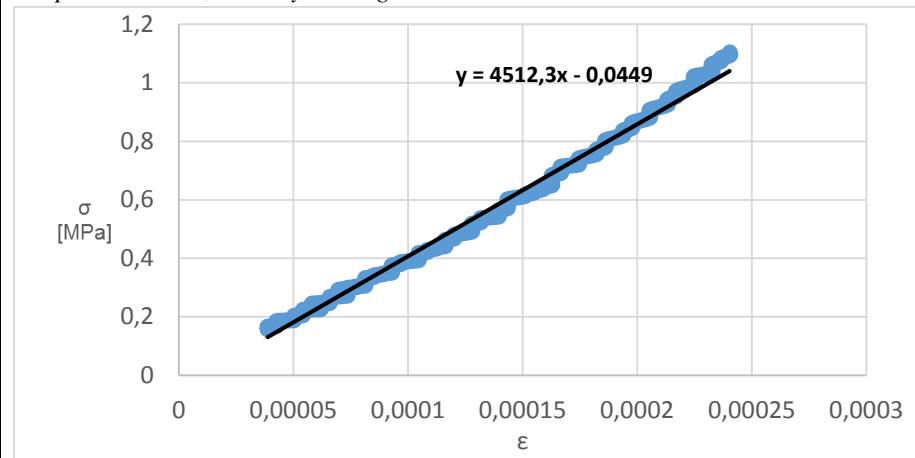
Graph 16: Wall B, 313 days curing – test 3.

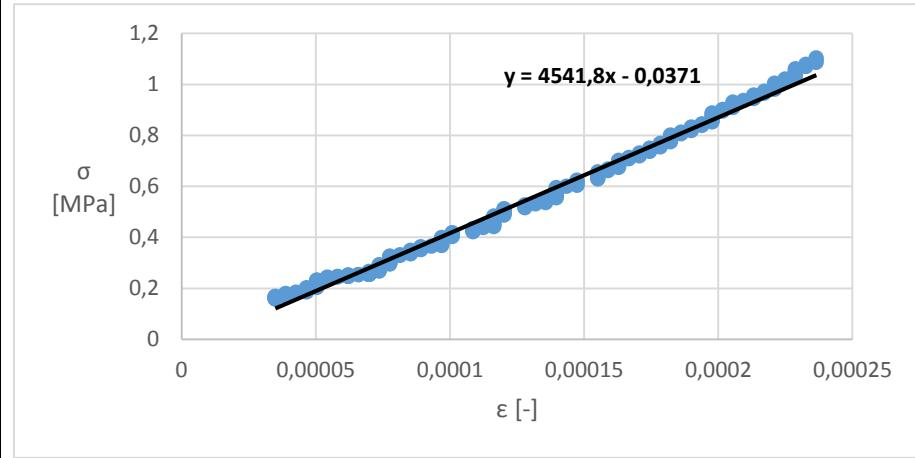
Graph 17: Wall B, 390 days curing – test 1.

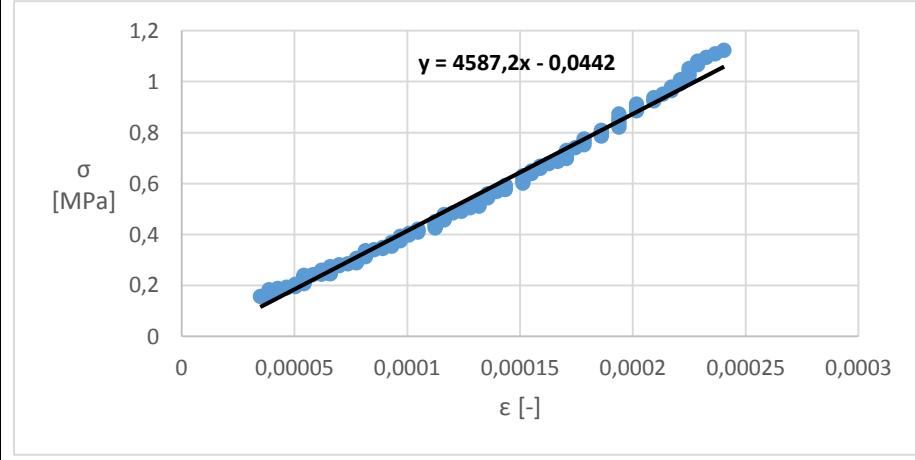
Graph 18: Wall B, 390 days curing – test 2.

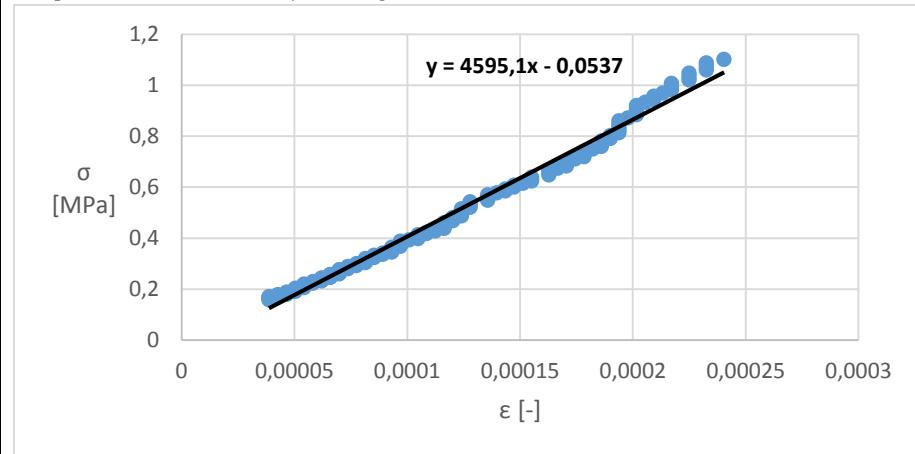
Graph 19: Wall B, 390 days curing – test 3.

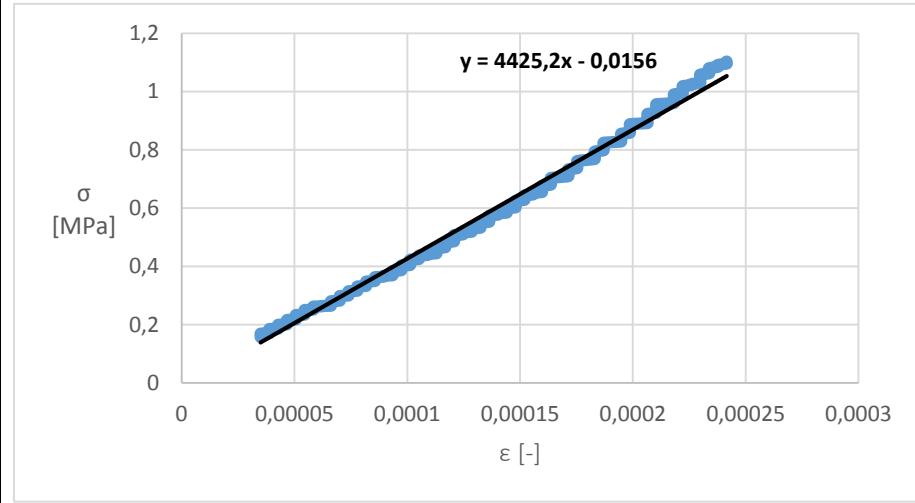
Graph 20: Wall B, 554 days curing – test 1.

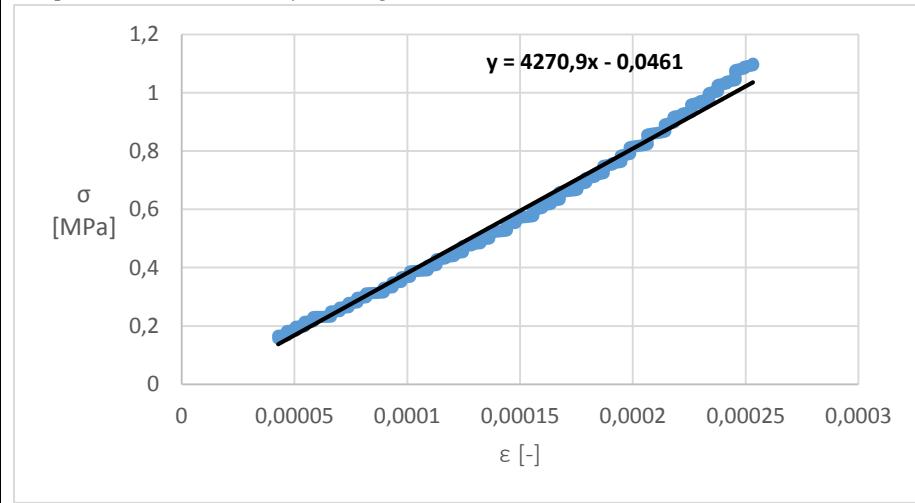
Graph 21: Wall B, 554 days curing – test 2.

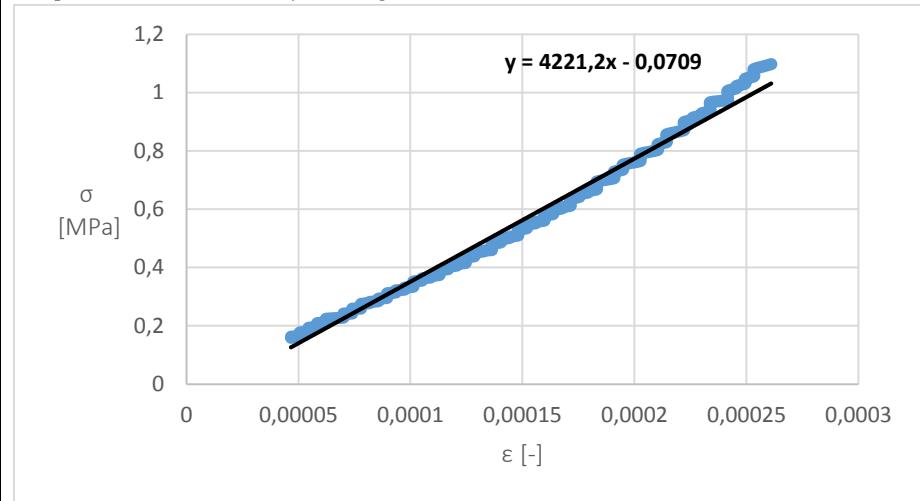
Graph 22: Wall B, 554 days curing – test 3.

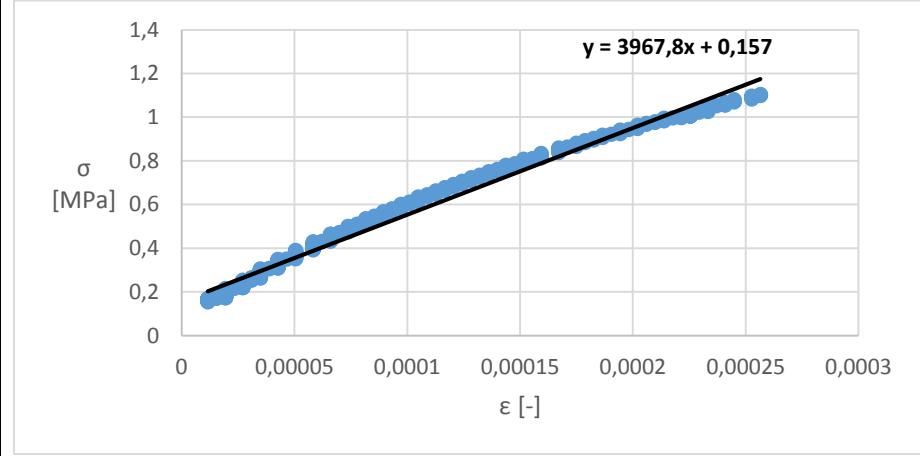
Graph 23: Wall C, 61 days curing.

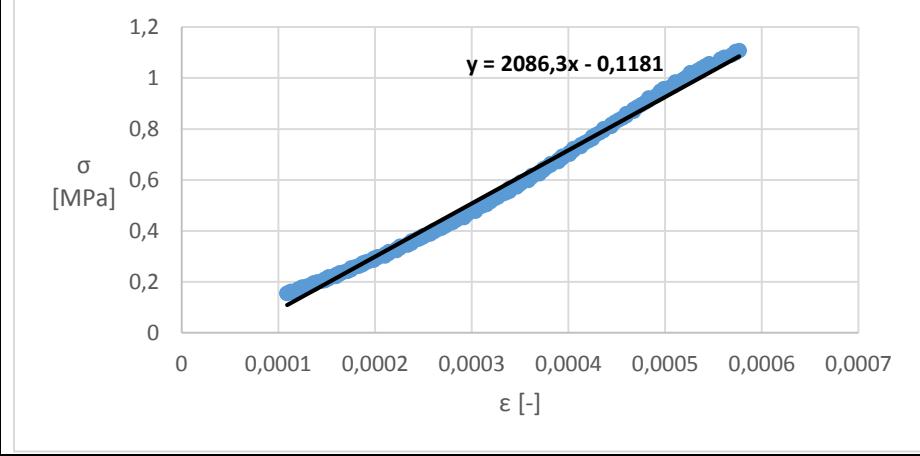
Graph 24: Wall C, 144 days curing.

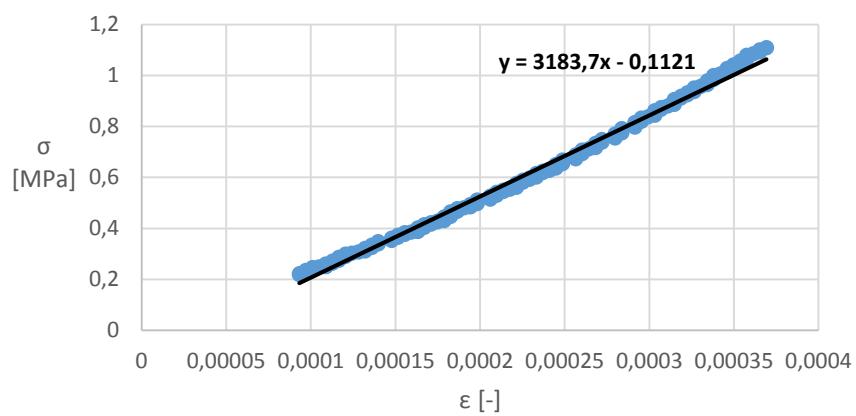
Graph 25.; Wall C, 229 days curing.

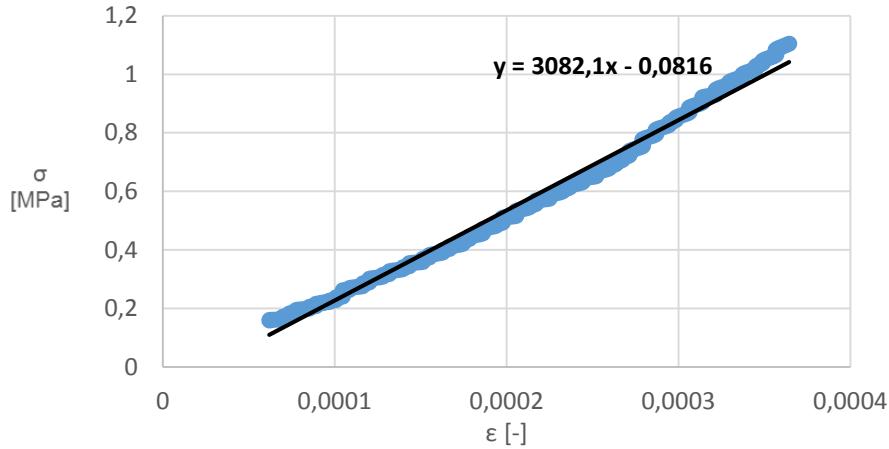
Graph 26: Wall C, 313 days curing – test 1.

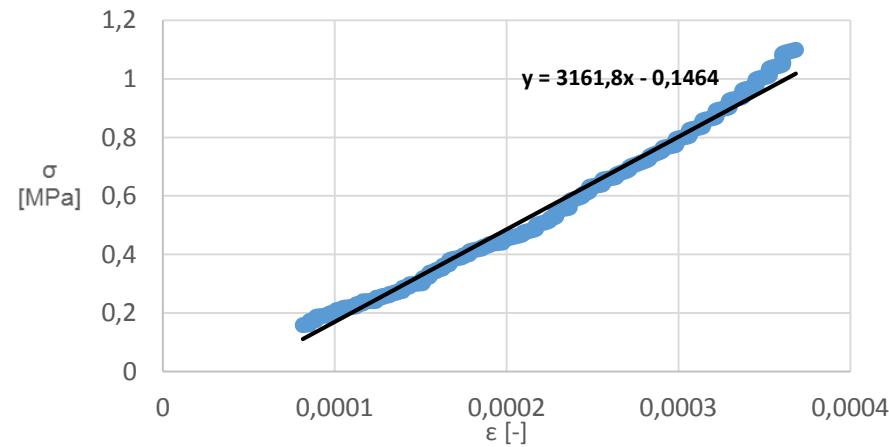
Graph 27: Wall C, 313 days curing – test 2.

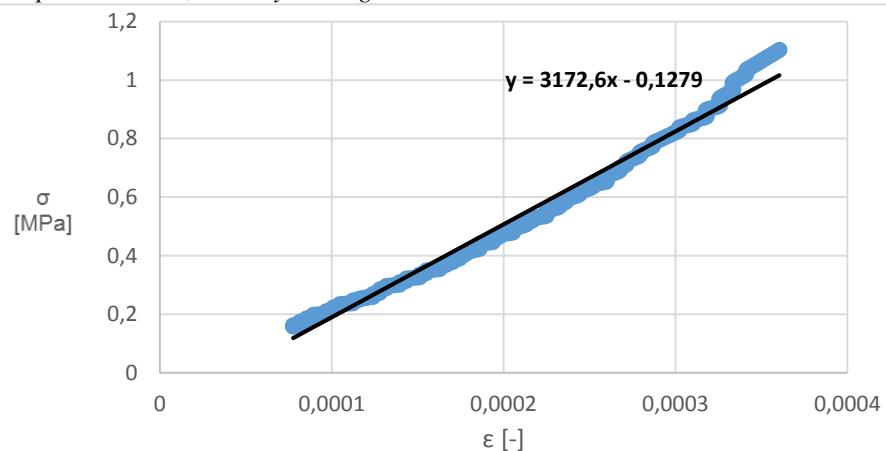
Graph 28: Wall C, 313 days curing – test 3.

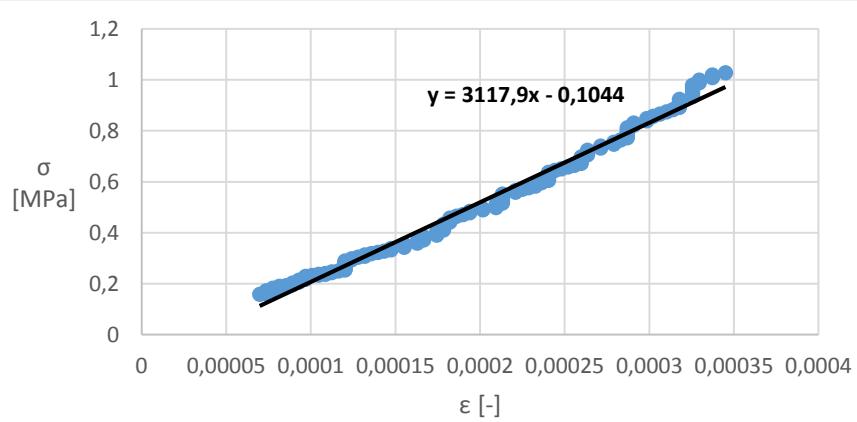
Graph 29: Wall C, 390 days curing – test 1.

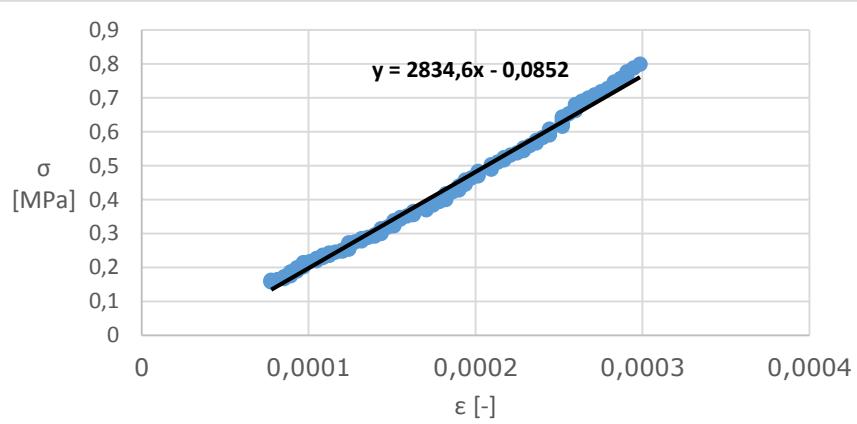
Graph 30: Wall C, 390 days curing – test 2.

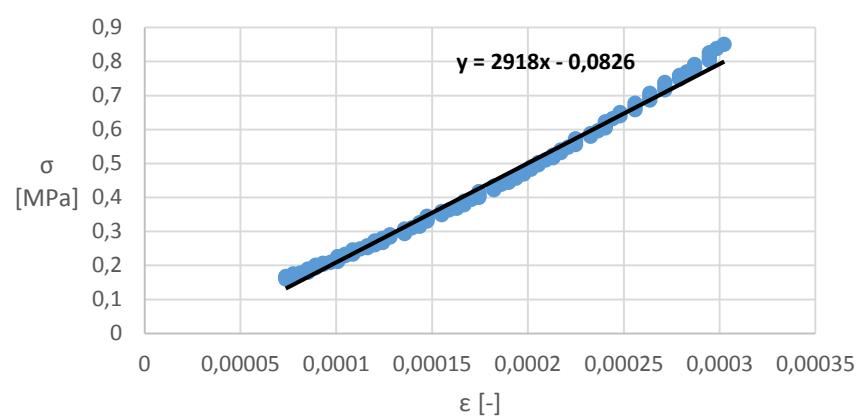
Graph 31: Wall C, 390 days curing – test 3.

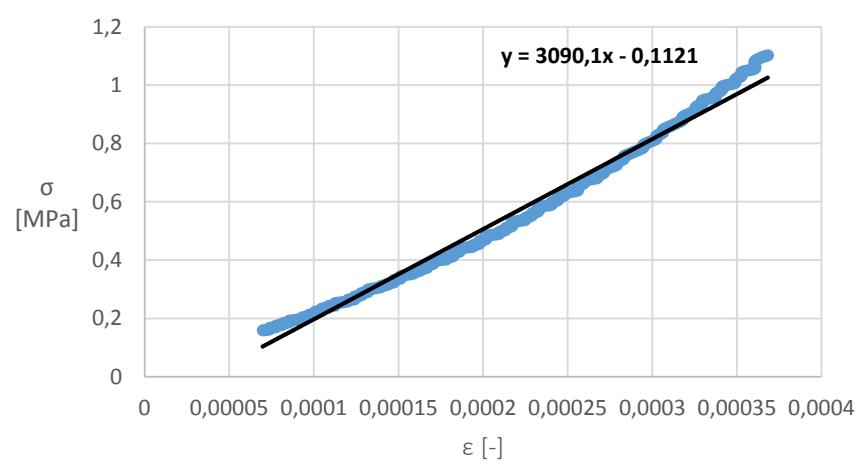
Graph 32: Wall C, 554 days curing – test 1.

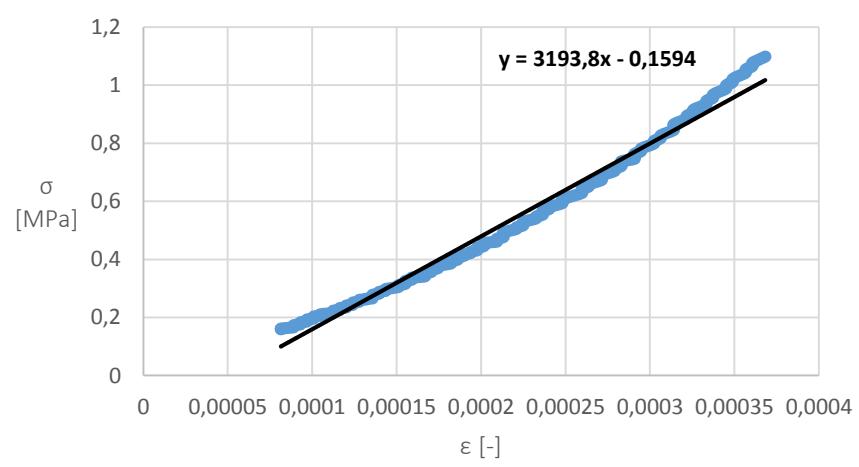
Graph 33: Wall C, 554 days curing – test 2.

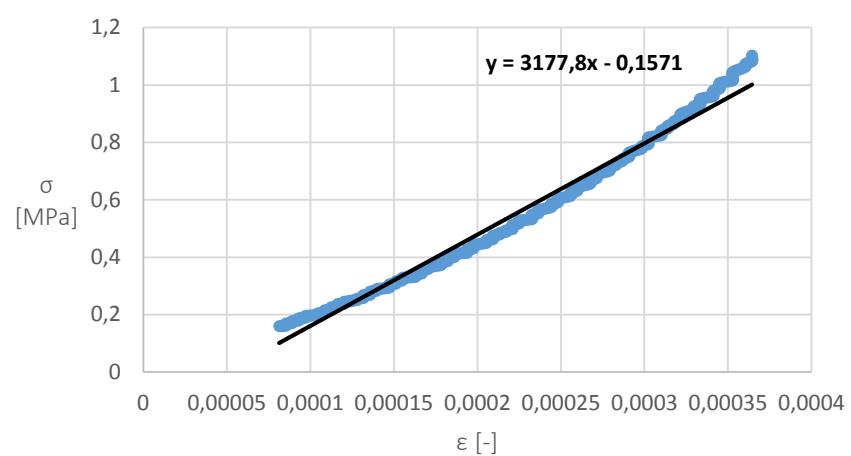
Graph 34: Wall C, 554 days curing – test 3.

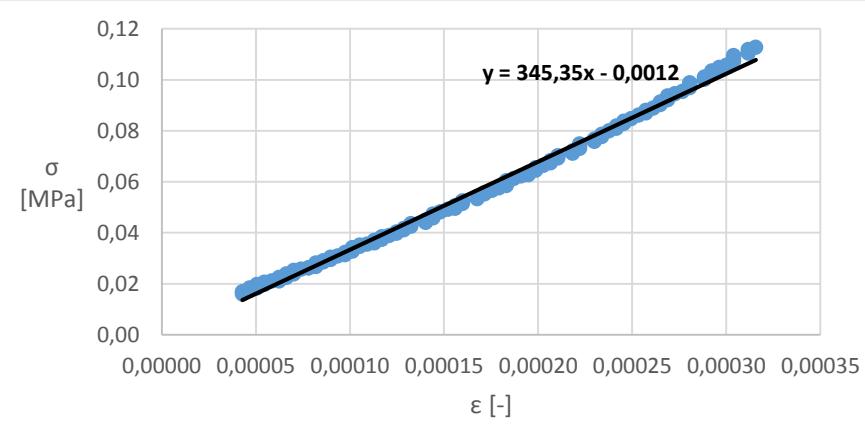
Graph 35: Wall E2, 28 days curing, wall 1 out of 3.

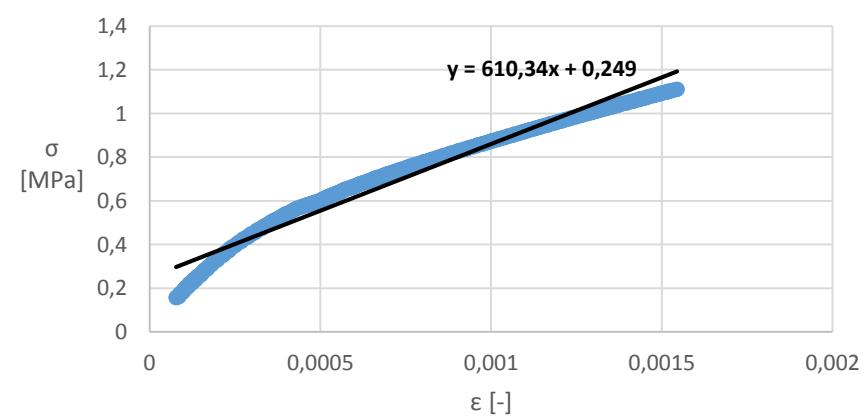
Graph 36: Wall E3, 28 days curing, Wall 2 out of 3.

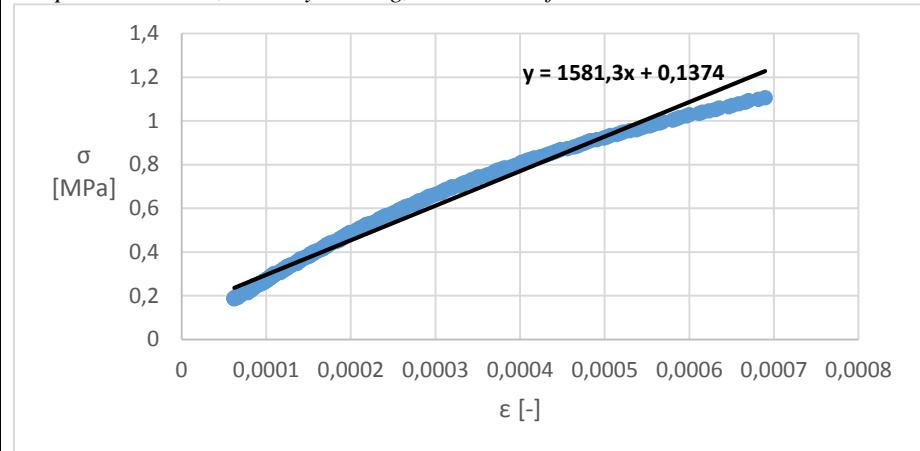
Graph 37: Wall E1, 117 days curing, Wall 3 out of 3.

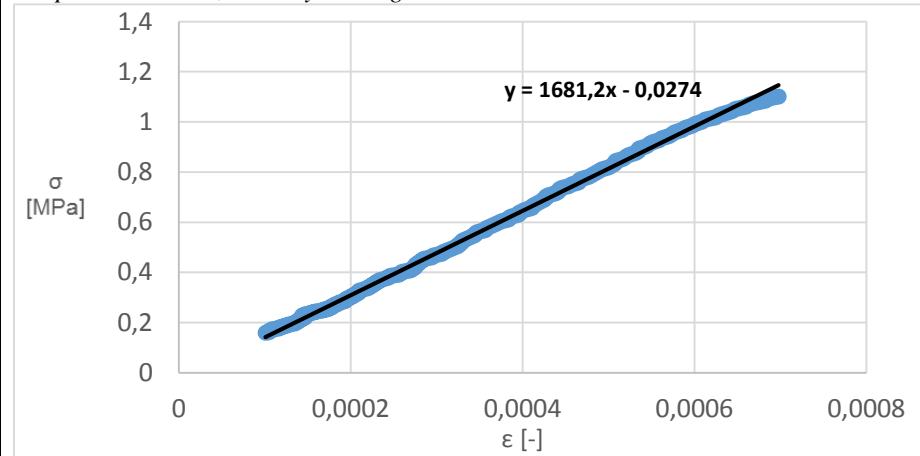
Graph 38: Wall E1, 188 days curing – test 1.

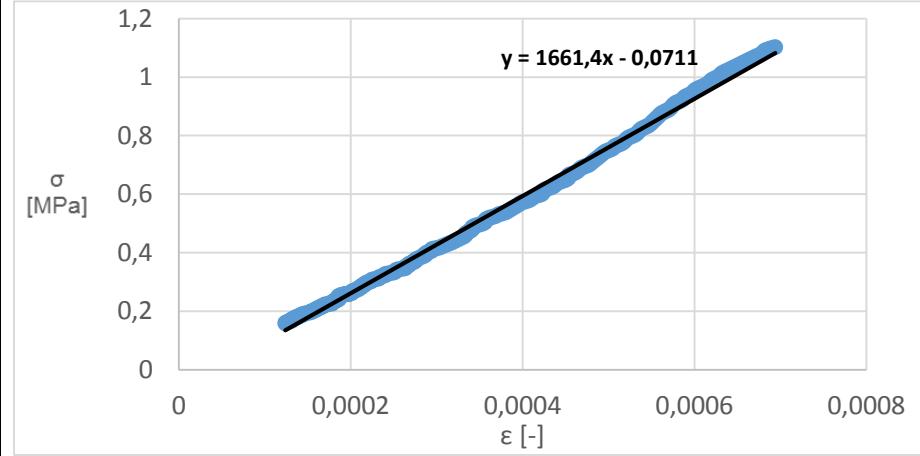
Graph 39: Wall E1, 188 days curing – test 2.

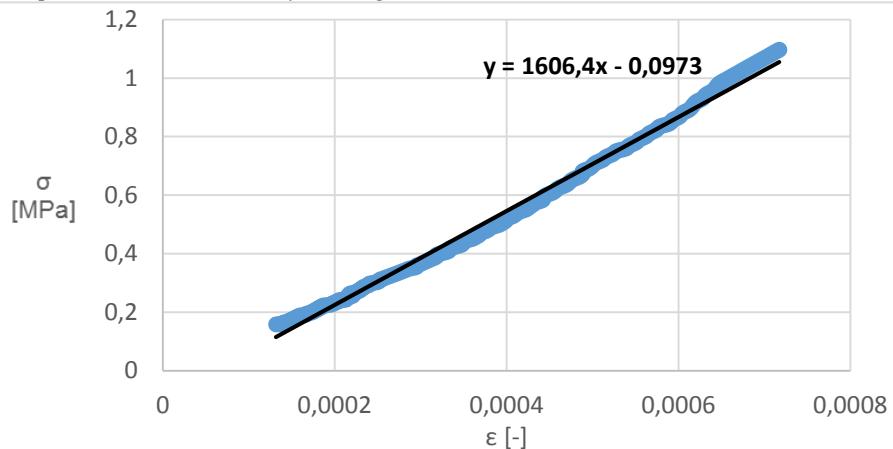
Graph 40: Wall E1, 188 days curing – test 3.

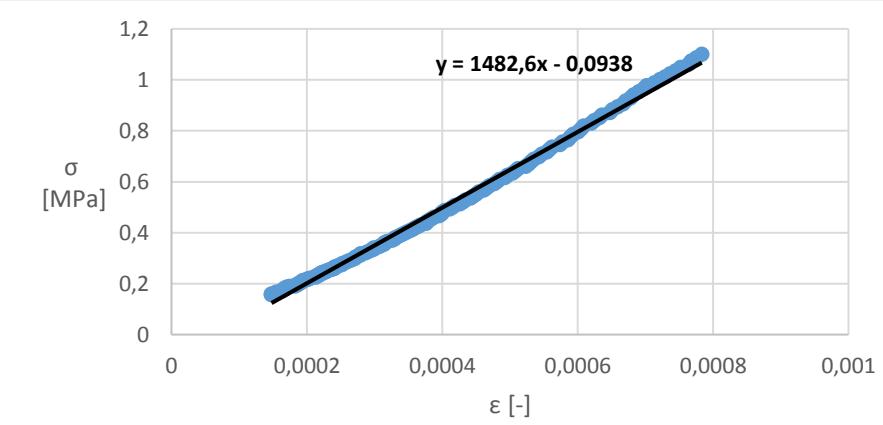
Graph 41: Wall E1, 267 days curing – test 1.

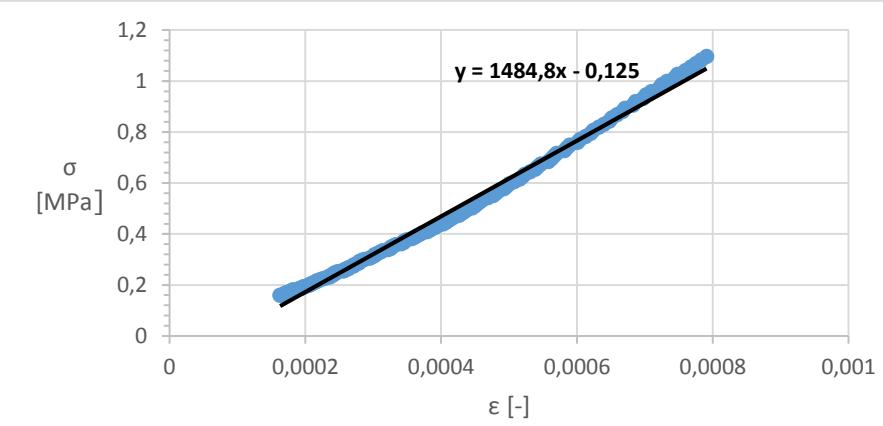
Graph 42: Wall E1, 267 days curing – test 2.
