Test report – Masonry based on lime mortar

Determining the Secant Modulus of Elasticity of Masonry based on lime mortar and measuring the long-term compressive and flexural strength of hardened lime mortar

2015-10-30, Danish Technological Institute, Masonry, Aarhus

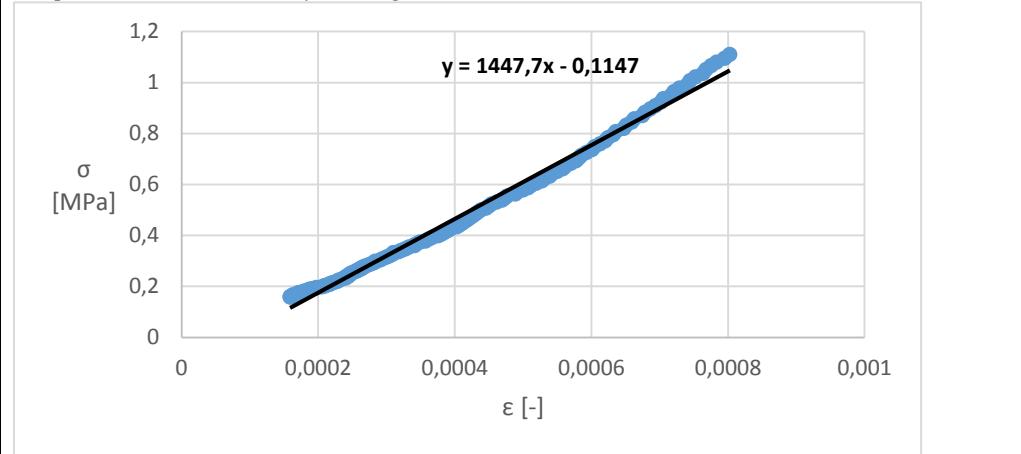
Graph 43: Wall E1, 267 days curing – test 3.

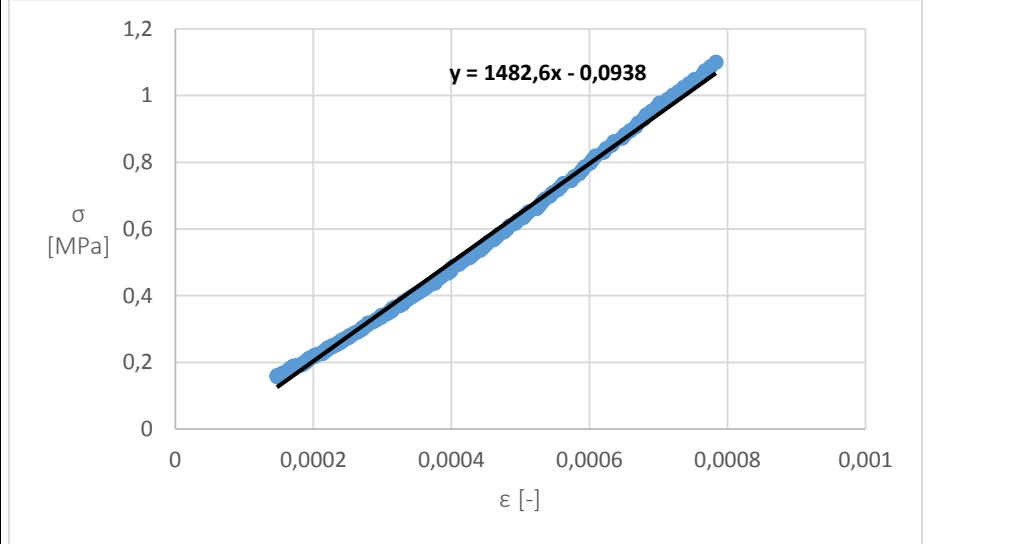
Graph 44: Wall E1, 265 days curing – test 1.

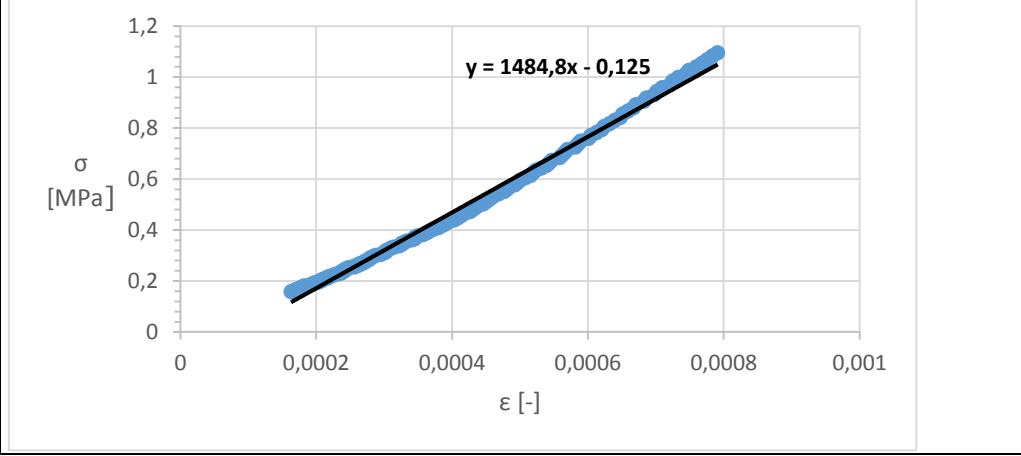
Graph 45: Wall E1, 265 days curing – test 2.

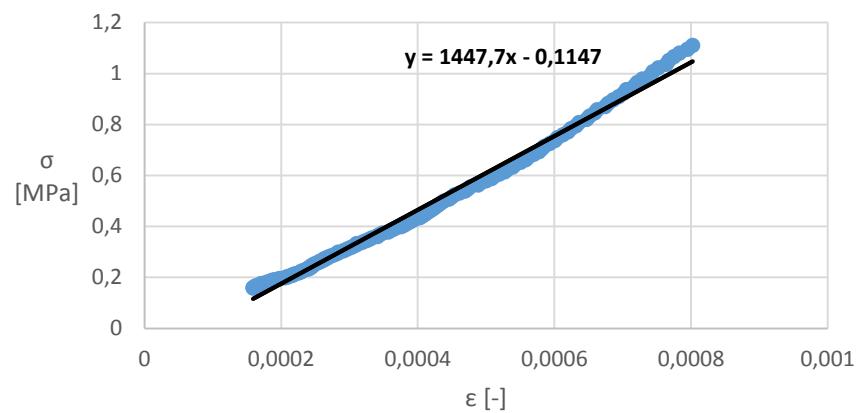
Graph 46: Wall E1, 265 days curing – test 3.

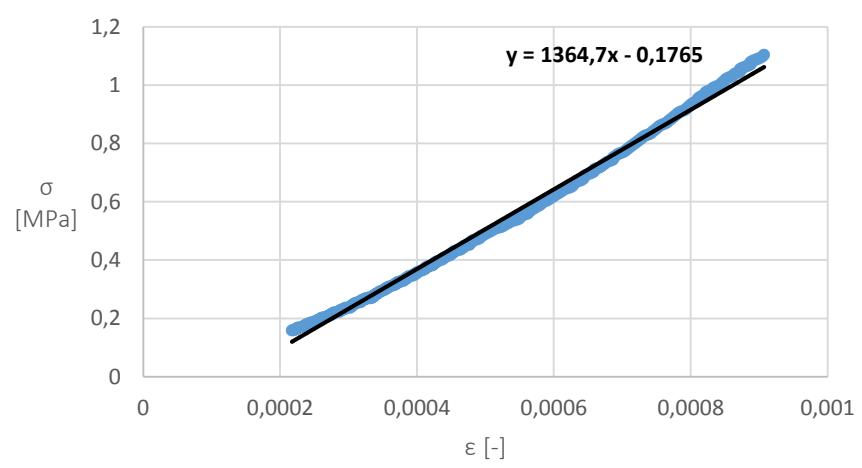
Graph 47: Wall E1, 429 days curing – test 1.

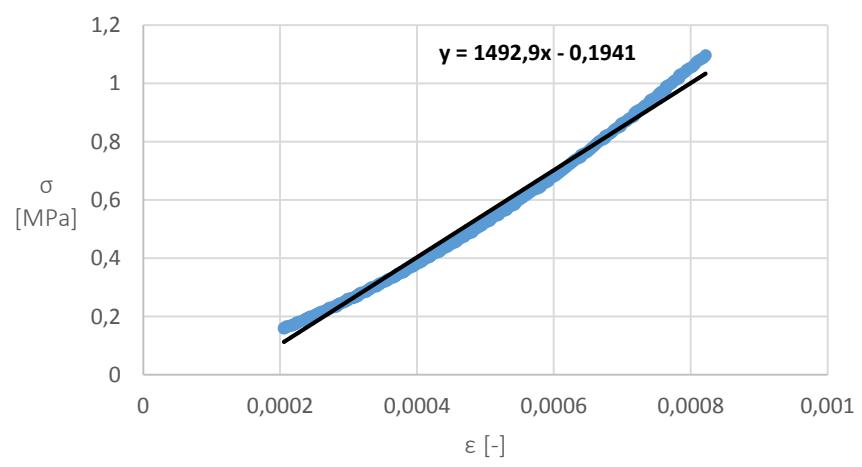
Graph 48: Wall E1, 429 days curing – test 2.

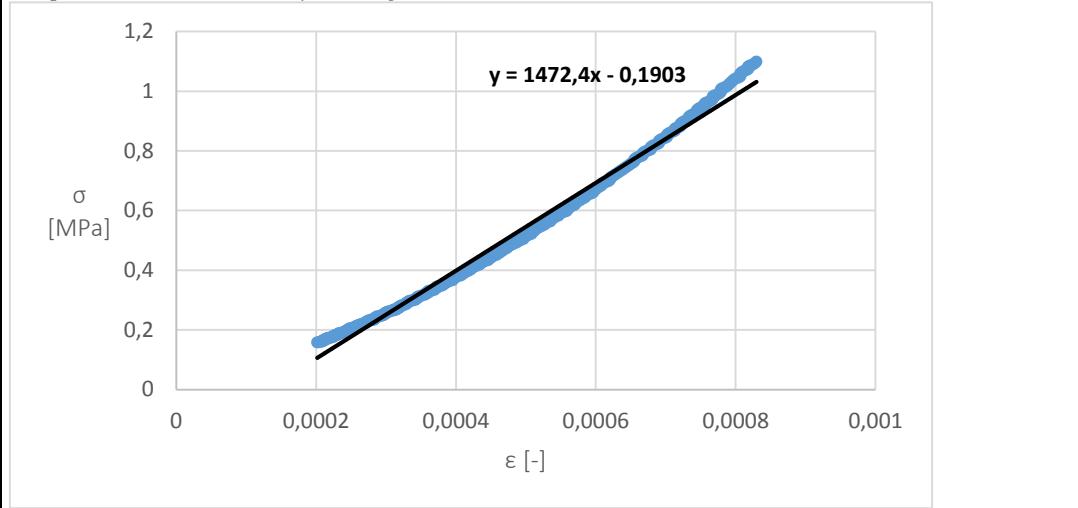
Graph 49: Wall E1, 429 days curing – test 3.
